**A Review and Consideration
of the
Structural Condition
of the existing
Windsor Bridge
Final Review**

Report on Structural Condition of the existing Windsor Bridge

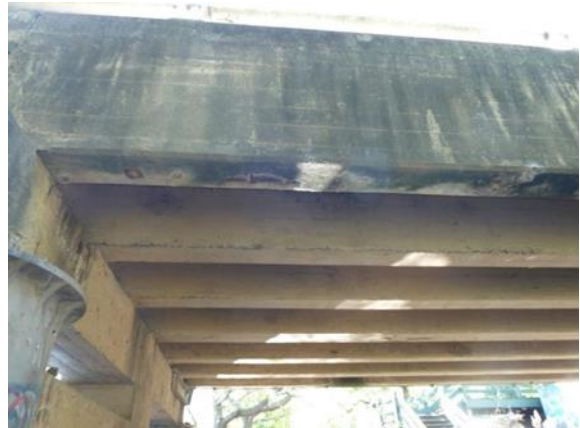
The scuppers are a significant cause of concrete deterioration as the beam and slab concrete adjacent to the scuppers repeatedly becomes wet and then dry.

Recommendations: GHD Oct 2003 recommended Re-alkalisation (A process used to arrest carbonisation) as it is deemed the most technically appropriate repair and the most cost effective repair option over the future service life of 25 years. RMS Inspection & Assessment Report Dec 2003 [B4V1.3] stated *"The structure assessed to be in poor condition"* and *"The recommendation of the report was to replace the bridge within 5 years"* based on the extensive repairs identified in the inspection & durability reports.

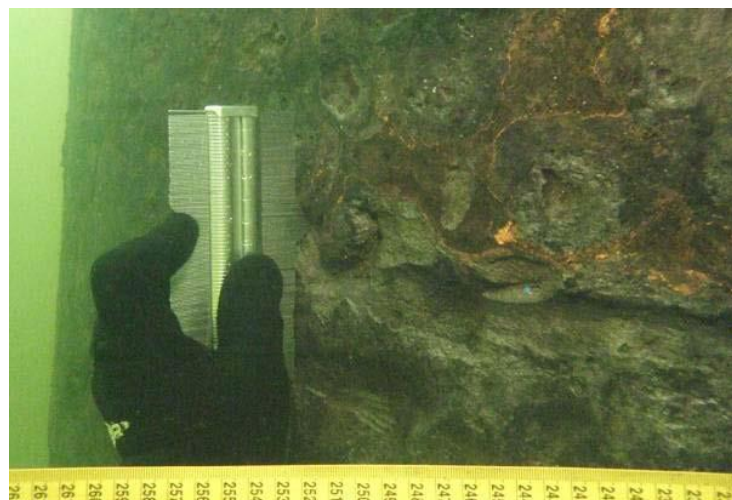
Extent: RMS first identified this in 2005 (CTI Underwater Graphitisation Survey [B4V1.5]) [D18]. CTI assessed the above water condition of the piers to be excellent. CTI identified graphitisation in piers 1, 5, 7 and 9. However *"there was no discernible pattern to the distribution of the residual wall thickness."* CTI subsequent survey (July 2011) [B4V2.15] indicated that *"the condition of the columns ...reveals*

that graphitisation has advanced to significant proportions. Indications are that in places there are more than 20mm of graphitised material present." This leaves an average structural thickness of 15mm which is roughly 50% of the original thickness. So graphitisation has corroded the caissons at a rate of approx. 15mm in 138 years or 0.11mm/year. It is evident that this is a very slow process.

Recommendations: From CTI 2005 report *“Should the bridge still be structurally adequate, further graphitisation of immersed surfaces can be prevented by installing impressed current cathodic protection to the columns, designed in accordance with AS 2832.3.”* Other recommendations centre on monitoring the situation particularly after flooding.

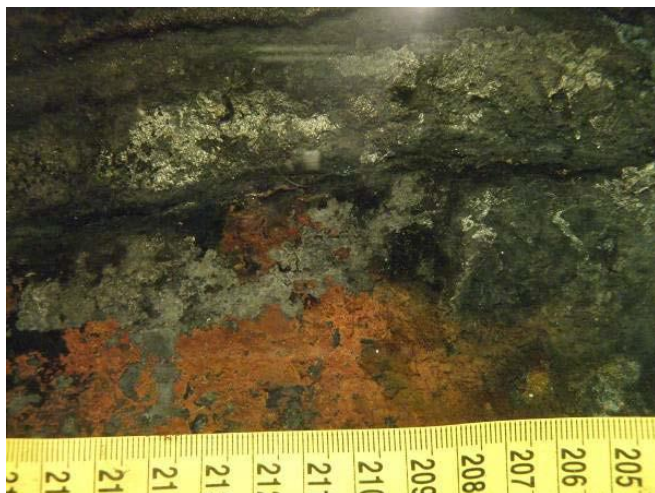
Extent: Pier caisson cracks (vertical & horizontal) observed in Pier 5 and to a lesser extent in Pier 6 are documented in the CDS Underwater Inspection Report of June 2011 [B4V2.15]. Horizontal cracks are present in these three columns including both columns of pier 5. RMS first identified these cracks in 2011 through the CDS inspection [D9]. Underwater inspections later in 2011 concluded there was no evidence that the cracks have widened or shifted since previous survey 2 months before. The report went on to say *“It appears the cracks are not new and have been present for quite some time, at least a few decades and possibly longer”*. The cause of the cracks is unknown.

Recommendations: A detailed structural analysis to determine the impact of the cracking on the bridge's capacity. That underwater inspection is undertaken after every major flood event.

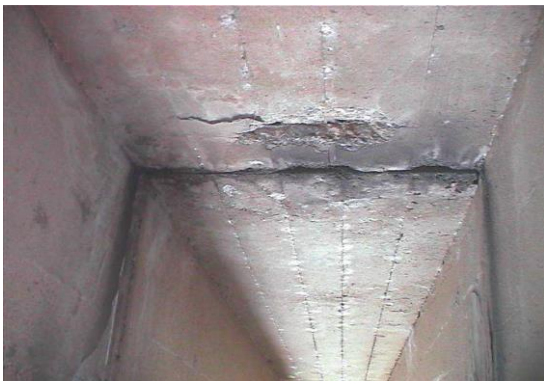
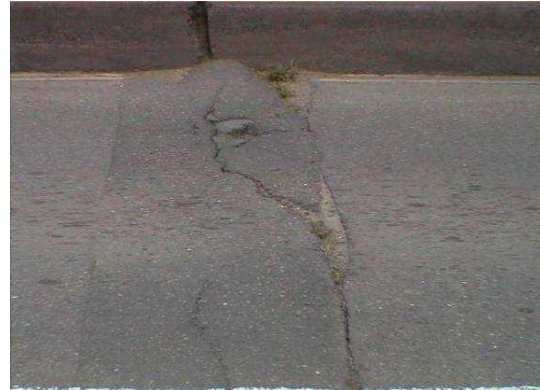
Extent: Deck joints are in poor condition which can be clearly seen from photographs. Ironically it may be unwise to repair them to their original design as it would change the load transfer of forces (as mentioned above).

No action has been taken to repair the joints. These repairs should not be done until the cracked piers (piers 5 and 6) have been repaired by providing them with a structural steel jacket as strengthening.

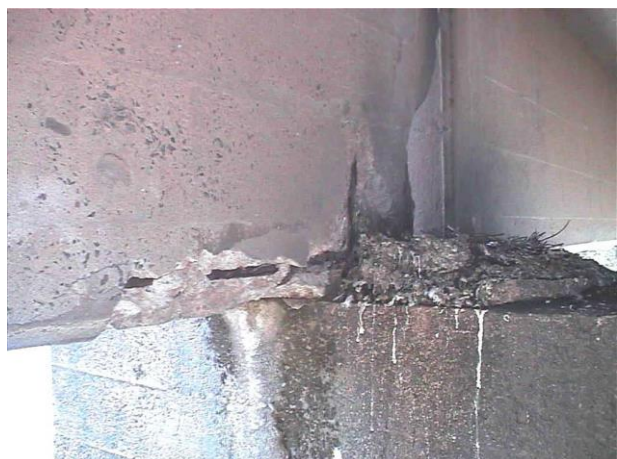
These by themselves do not warrant demolition of the bridge. However, if left untreated corrosion of the reinforcement at the beam ends will undermine the integrity of the structure.

Recommendations: Repairs recommended in RMS Report from December 2003. [B4V1.3]

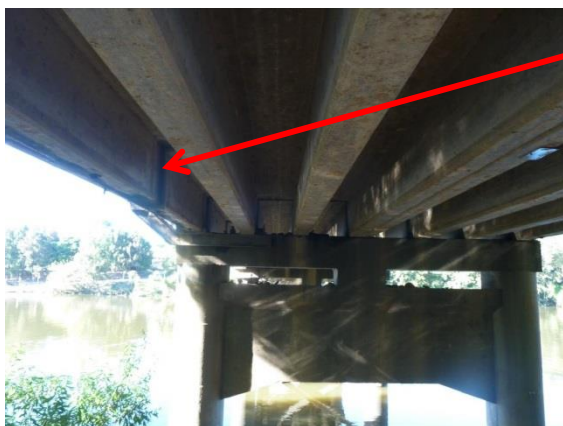
Span 11

Moisture from scupper

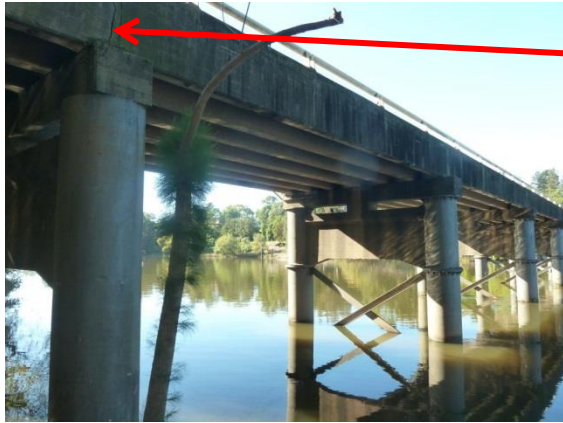
Span 10 and 9 beyond

Crack over pier headstock

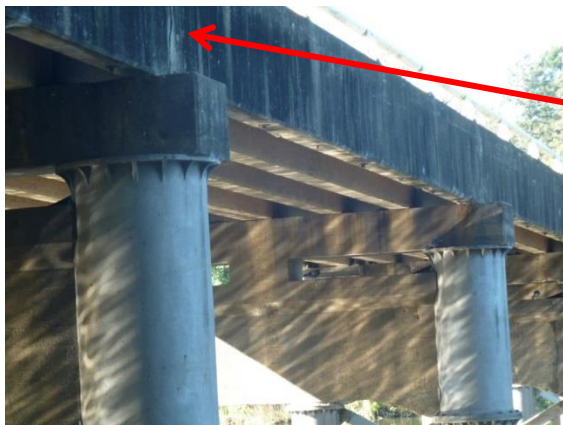
Span 9

Cracks over pier headstock

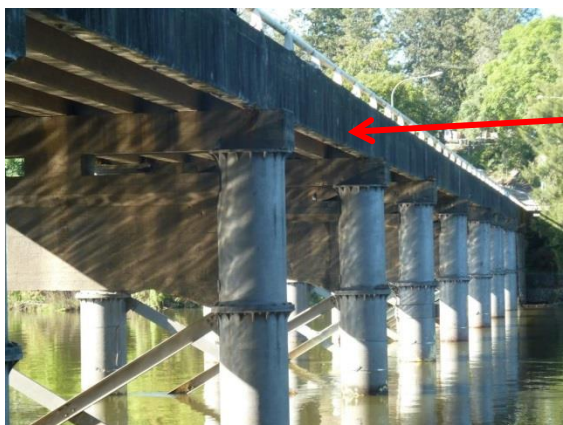
External beams showing
greater weathering

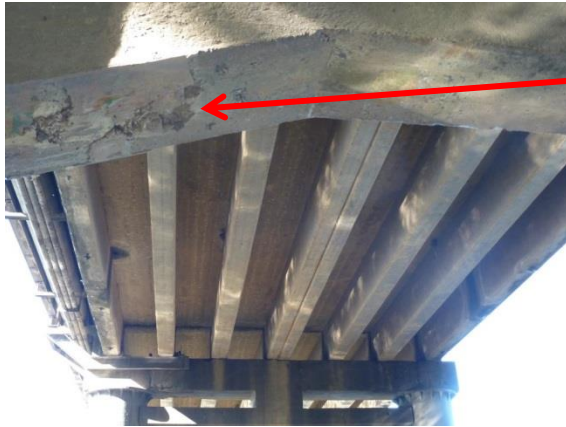
Span 10

Diaphragm showing poor
quality concrete

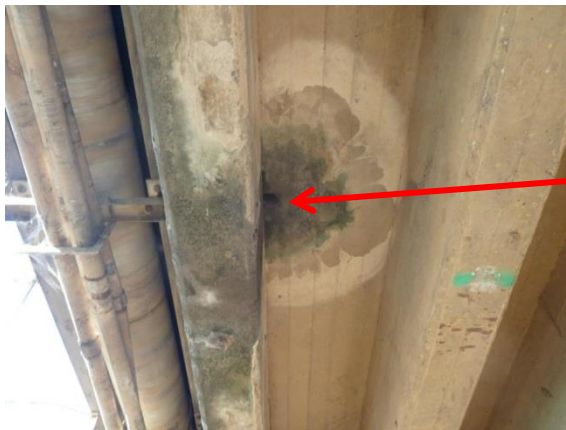
Span 10

Scupper impact on concrete
and external beams
showing greater weathering

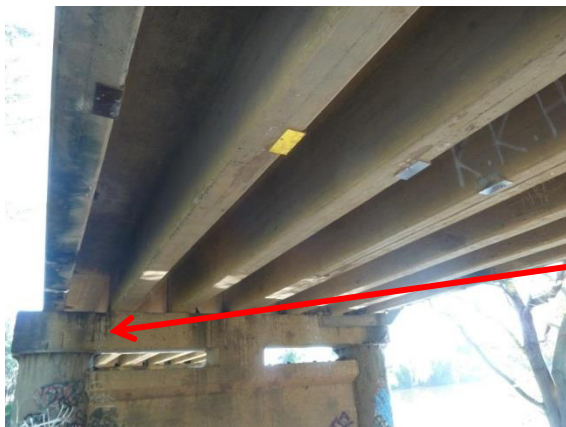
Span 2

Headstock reinforcement
showing perhaps as a result of
insufficient concrete cover

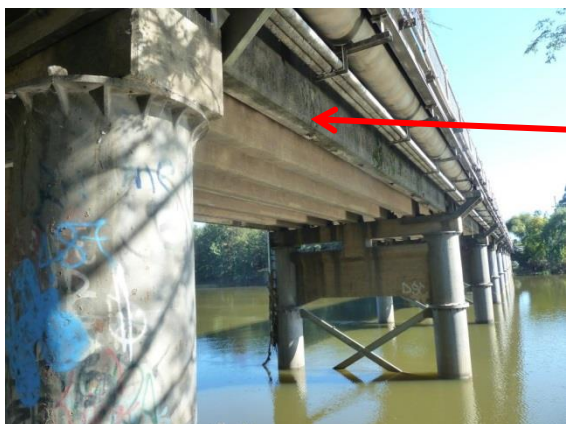
External beams are clearly
showing greater weathering
on the east side as well.

Other beams look good.

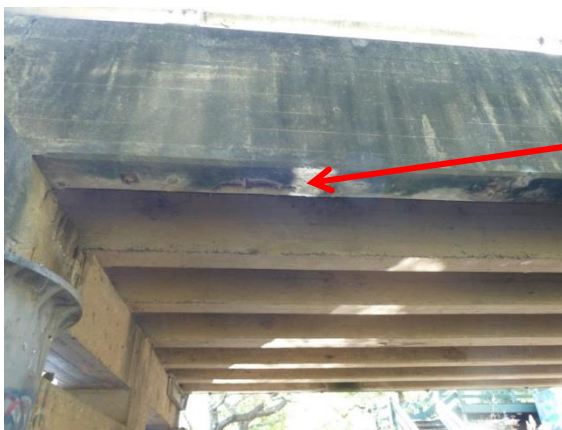
Span 1

External beams showing
greater deterioration

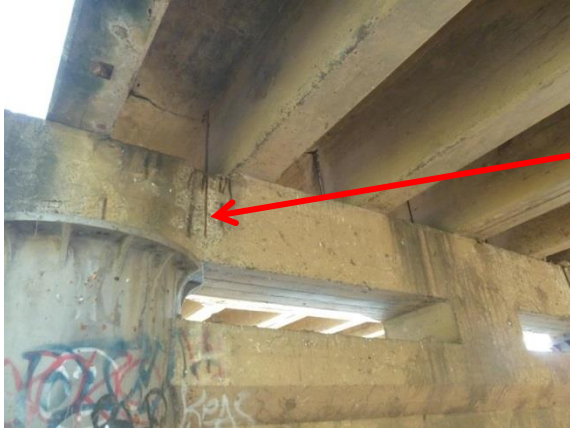
Span 1

Headstock reinforcement
showing perhaps as a result of
insufficient concrete cover
