Statement of Heritage Impact
Hawkesbury River Bridge (RTA No.415),
Windsor, NSW

Report Prepared for
NSW Roads & Traffic Authority
Environmental Services Sydney
October 2008
Final Report

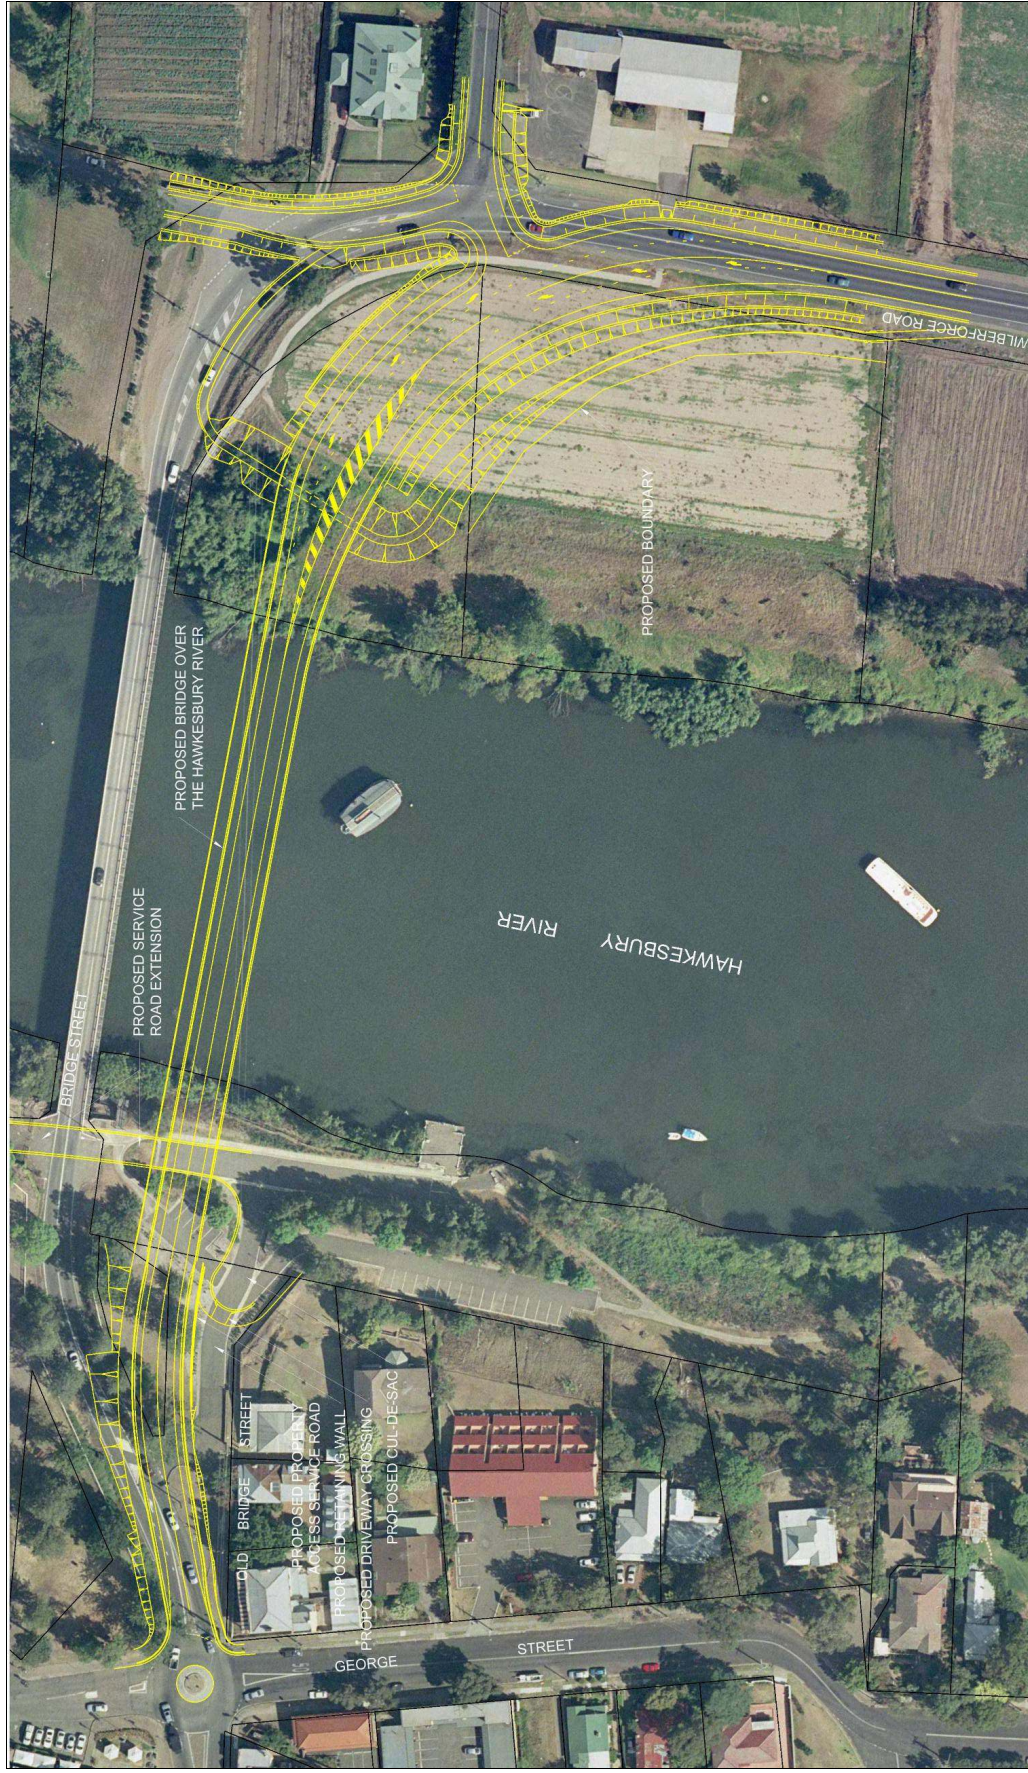
Figure 1.3: Proposed bridge replacement location and layout (RTA 2008).

The proposed location for a new bridge was determined by the RTA through an options report study (RTA July 2008a). The study assessed various strategic concept options to facilitate the selection of a preferred option. Ten route options were examined and investigations into the retention of the existing Bridge identified significant structural deterioration. As such, the cost and provision for traffic to accommodate remedial measures of the existing Bridge justified the consideration of a bridge replacement. Option 1, the preferred route option was selected as it offered a high level crossing 20 metres downstream of the existing Bridge. The proposed replacement bridge would be approximately 430m in length consisting of 70m of new southern approach, 200m of new bridge and 160m of new northern approach. The proposed new bridge will comprise of ten spans and nine piers with abutments at either end. Refer to Figure 1.3 & 1.4.

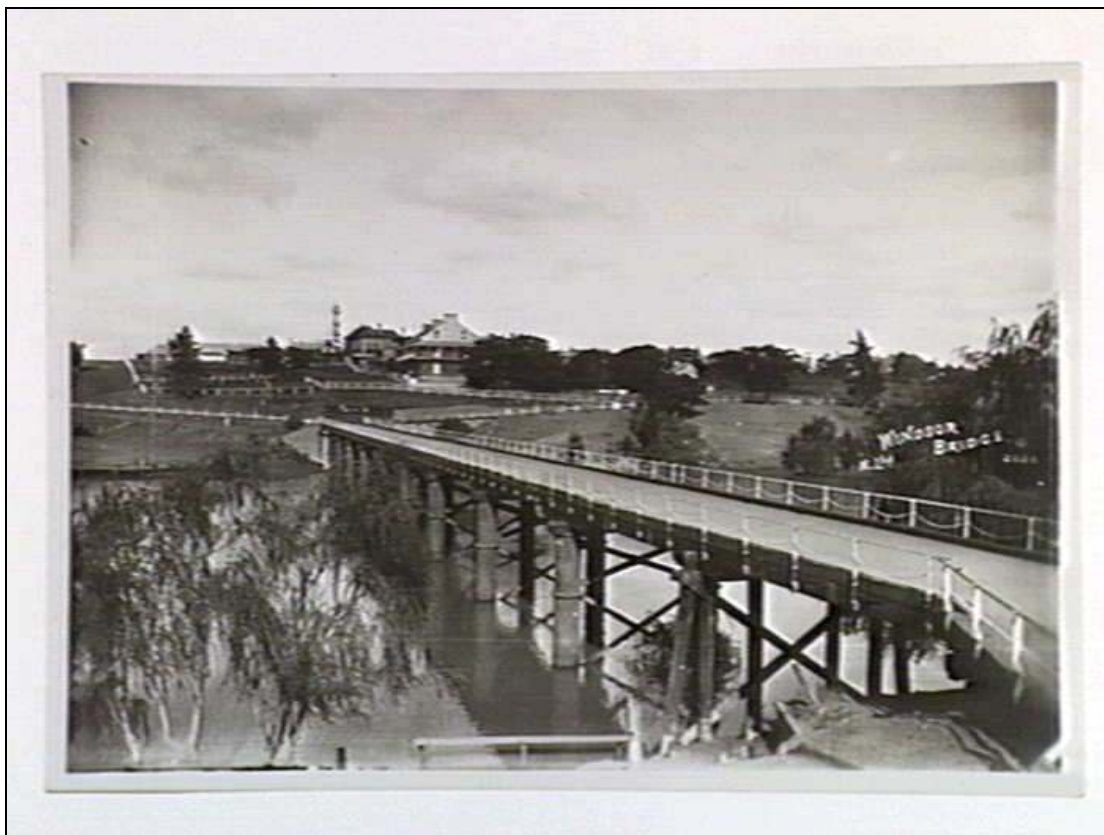
Figure 3.5 Hawkesbury River Bridge after being raised in 1896 but prior to concrete re-decking in 1922 (State Library of NSW).

Raising the bridge was effected through the addition of eight foot cylinders on top of the extant columns. The deck was laid diagonally in tallow wood with kerbing of ironbark. The works also included new approaches to the Bridge, which greatly increased the ease with which traffic could access the Bridge – access from the Wilberforce side had been difficult for horse-drawn drays (*Windsor and Richmond Gazette* 3 April 1897). Further work was undertaken on the Windsor approach in 1934 to meet the requirements of increased motor vehicle traffic (Bowd 1982:64).

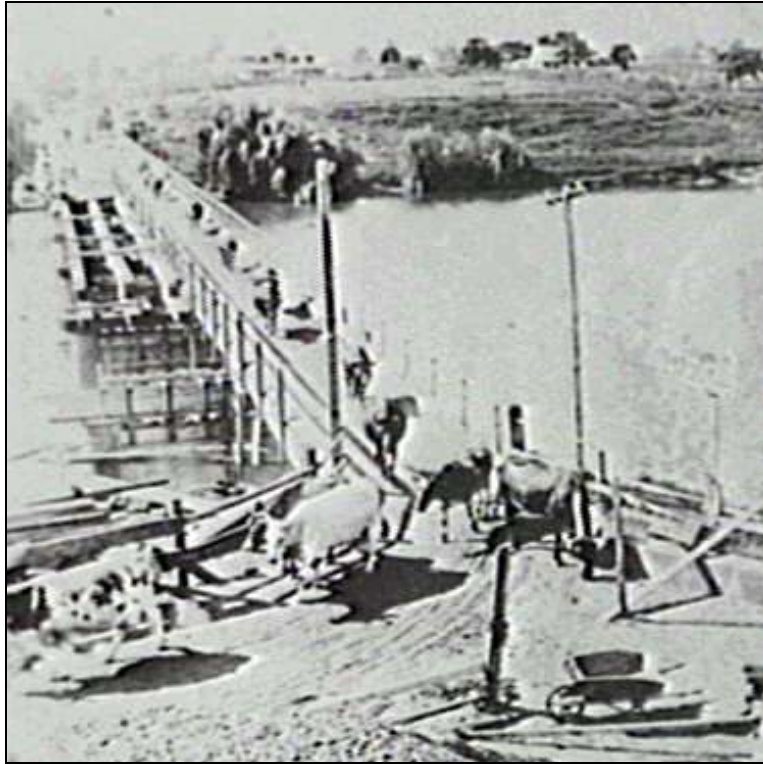
Figure 3.6 View Of Hawkesbury River Bridge during concrete re-decking operations in 1922 (Hawkesbury Regional Library Collection).

The timber decking was replaced with concrete in 1922. An Index of Public Works and Main Roads, Road Bridges, Public Ferries and Punts (SR 12638 item 3/886) inaccurately cites the date of Bridge construction as 1922, but this is thought to relate the re-decking work. This reference possibly gives rise to several other erroneous references to the Bridge's construction in 1922 (eg. O'Connor 1984: 14). The Index lists the cost of the Bridge at £13,370, although it is unclear if this figure refers to the original construction of the Bridge or the re-decking.

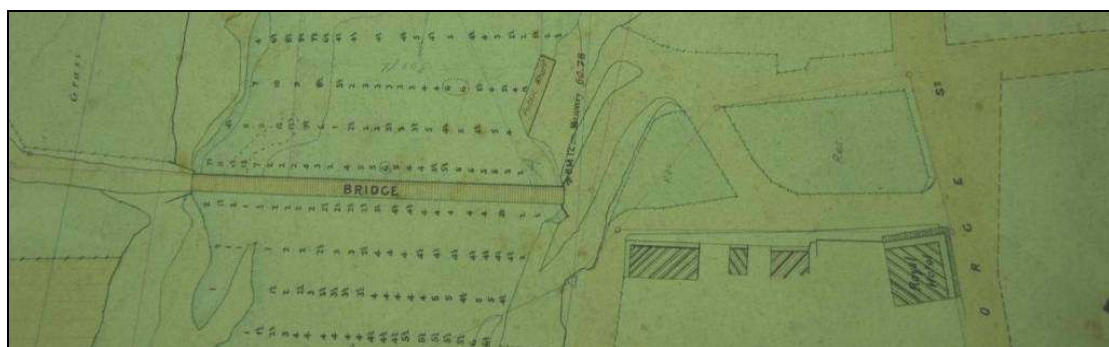
Figure 3.7 Photograph of a plan showing the Wharf at Windsor in relation to the Bridge and Thompson Square 1890 (S.R. 11/1653 x1081).

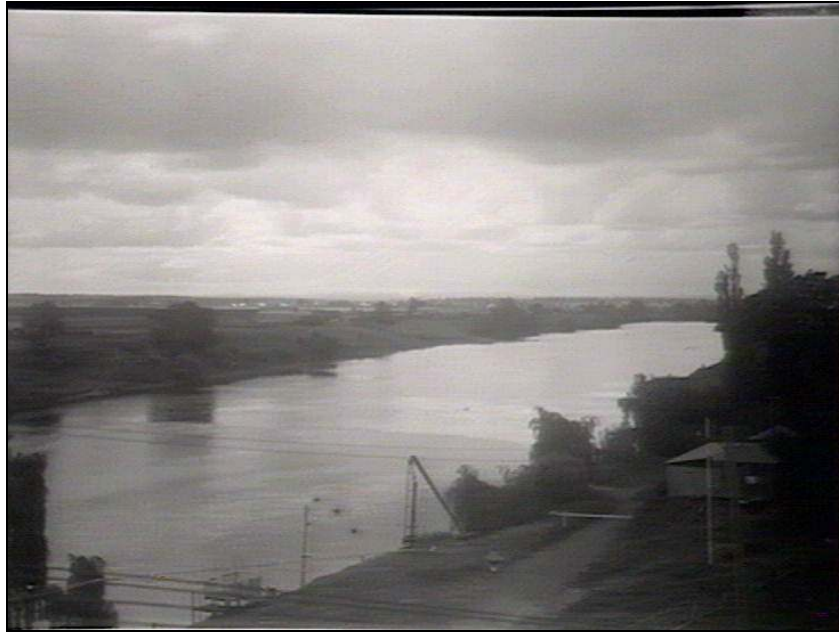
Figure 3.8 View downstream from Hawkesbury River Bridge showing the Windsor Wharf in the immediate foreground. (State Library of NSW) 1947.

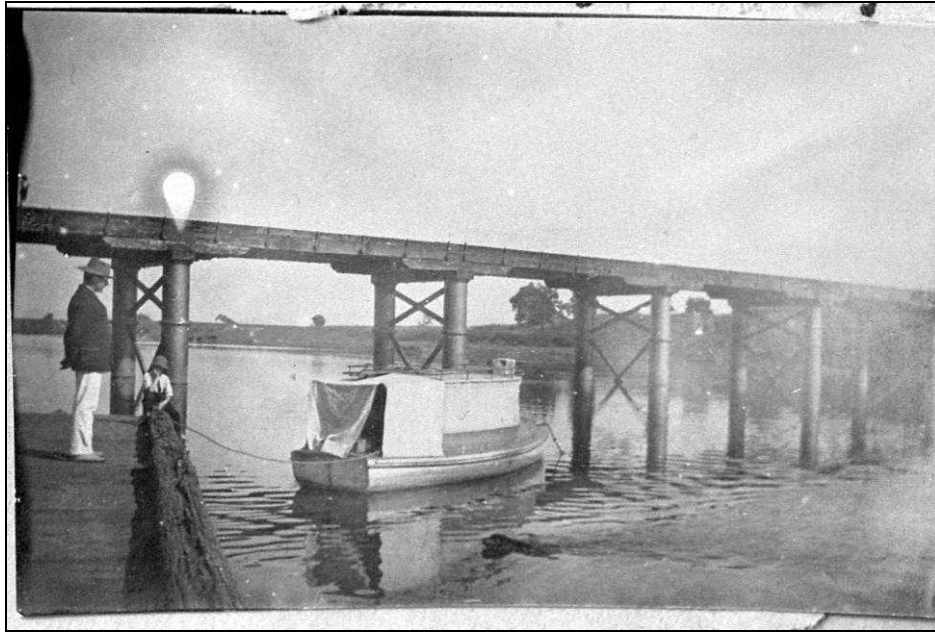
Figure 3.9 Looking upstream towards Hawkesbury River Bridge from Windsor Wharf (Hawkesbury Historical Society Collection, courtesy of Hawkesbury Regional Museum) Circa 1896-1922.

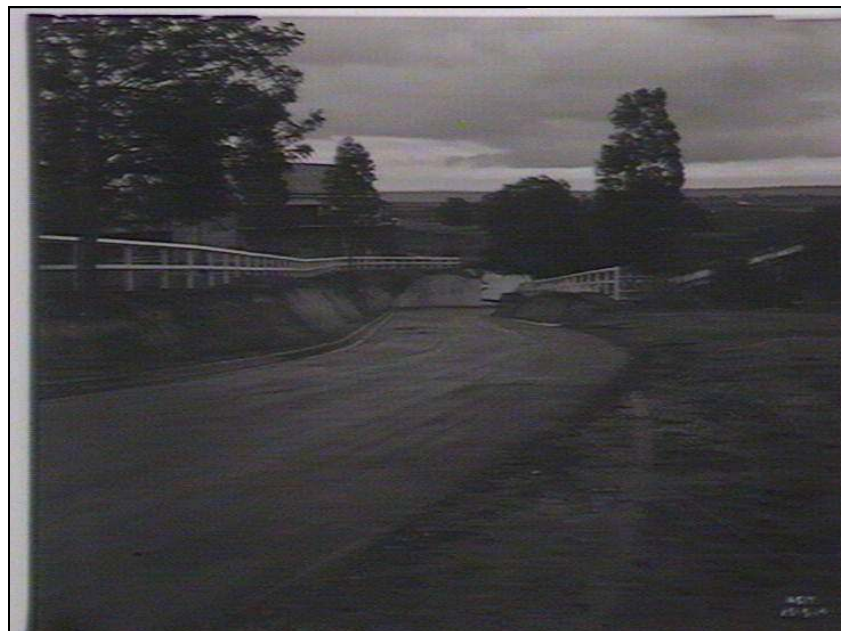
Figure 3.11 View from Thompson Square towards The Hawkesbury River Bridge (State Library of NSW) 1934.

The current approach and road alignment was put in place in 1934. These works included cutting and infill of the land to level with the Bridge, which again significantly altered the Square (Higginbotham 1986:31, Burns and Roe Worley 2005).

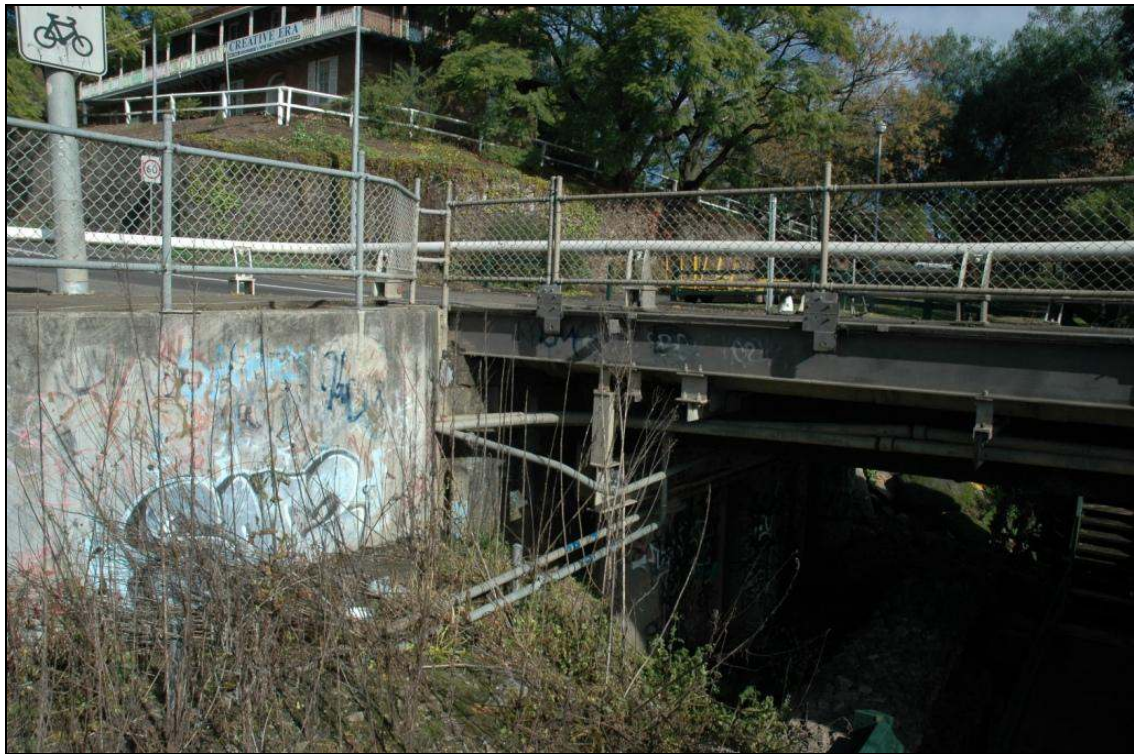
Figure 4.1: View of Abutment A, Windsor side, with endwall and wingwall elements visible. Also visible is the new handrailing installed in 1982.

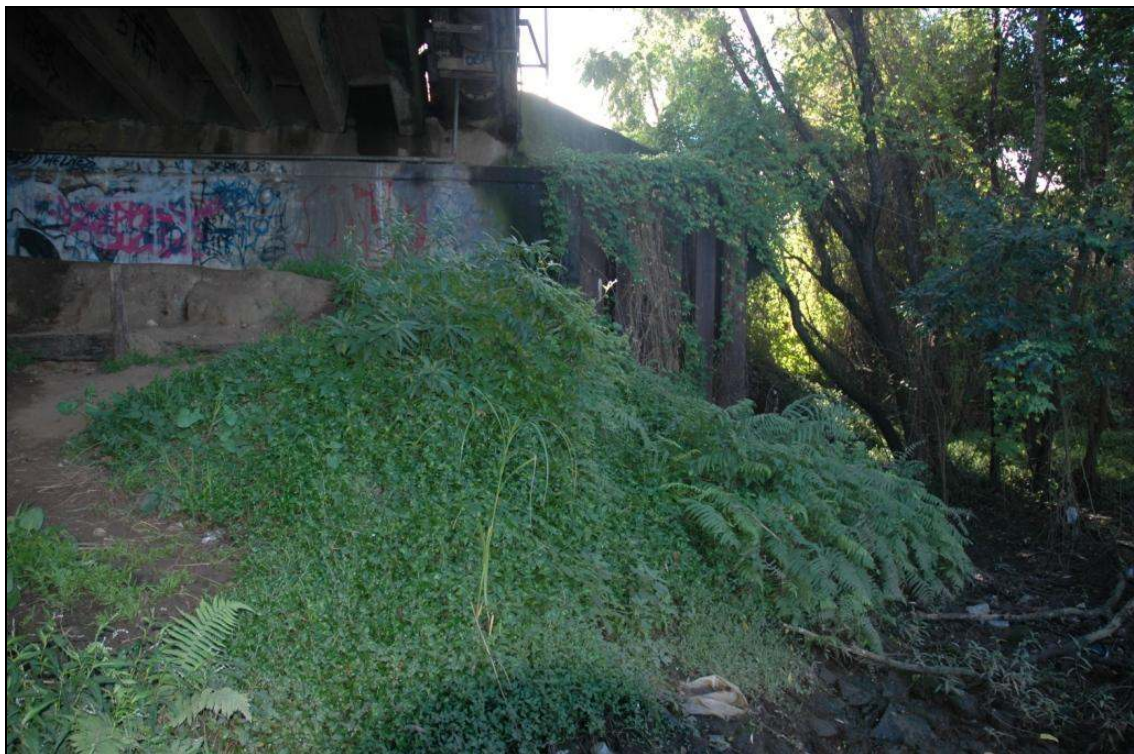
Figure 4.2: Abutment B at the Wilberforce side, showing concrete construction and steel wingwalls.

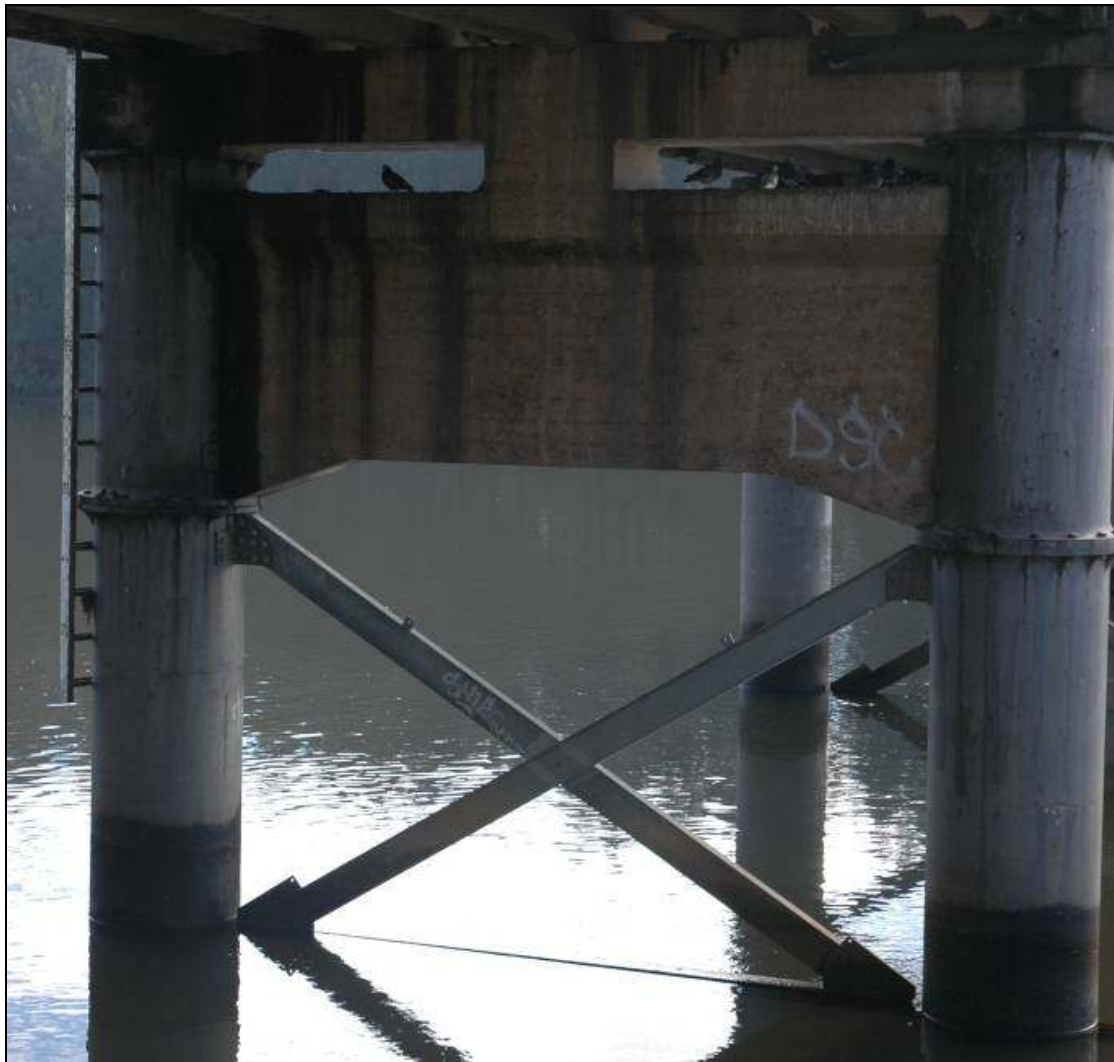
Figure 4.3: Iron piers and cross-bracing with concrete cross-girder added in 1922.

Strength is critical as the piers are required to bear the weight of the bridge in addition to any and all traffic that uses it. In the case of this Bridge, the quality and skill of the construction of the piers is most evident in the fact that a bridge constructed in 1874 with timber decking for a relatively low traffic density is still capable of reliable operation with a heavy concrete decking and high traffic density with a much higher gross weight, as well as a steel and concrete footway erected in 1968.

These piers are in good condition with ongoing inspection and maintenance. The major areas of concern have been rusting and abrasion on the upstream side of the piers resulting from impacts by flood debris.

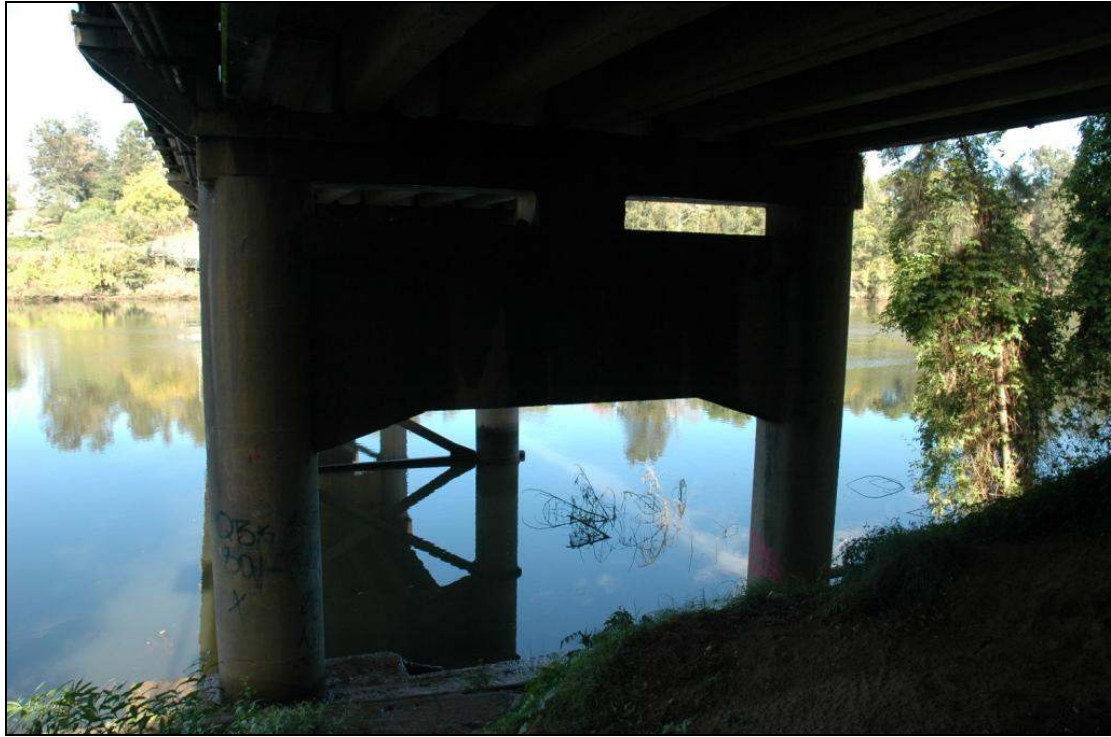
Figure 4.4: Mass Concrete Pier at Wilberforce end of bridge. Note the lack of cross-bracing and absence of iron casing on the piers.

The presence of the concrete pier shows how the Bridge design has been adapted over time in order to cater for changing needs. It demonstrates a history of adaptation of an older, reliable design rather than its replacement.

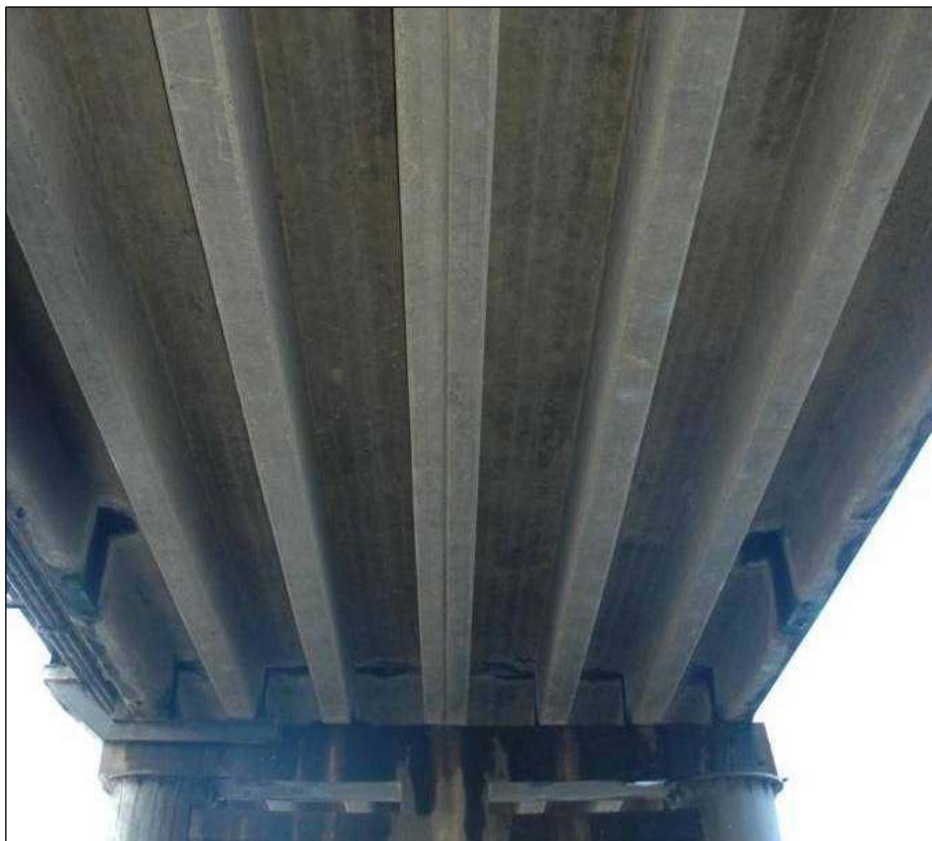
Figure 4.5: Underside view of concrete beam girders. Note the line between the central beams showing where the two sides were constructed separately.

One of the maintenance issues associated with reinforced concrete spans include spalling, where reinforcing steel within the concrete becomes exposed to the elements and rusts, which leads to damage to the concrete as the rust expands to six times the volume of the steel. This can have significant implications for structural integrity if the spalling penetrates deep into the concrete structure. Spalling was first reported on the Bridge in 1966 and subsequently in 1974, but was considered to be present only on the surface and a cleaning and patching job was completed. The concrete girders and headstocks were tested and found to be structurally satisfactory in 2003 (RTA File No. 91.1526.3).

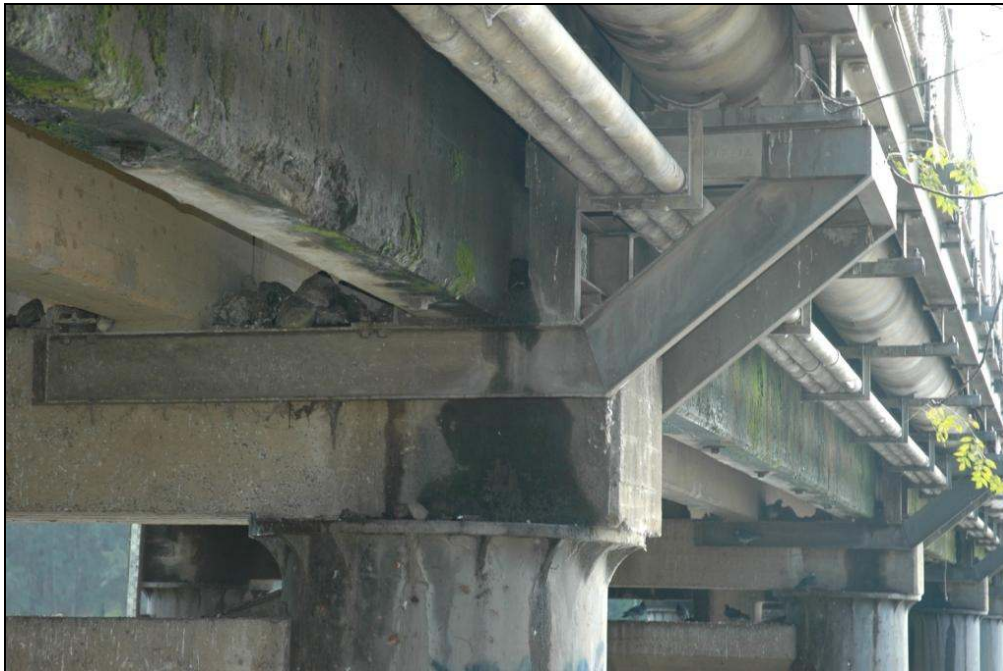
Figure 4.6: Underslung cantilevered footway brackets showing services attached to bridge.

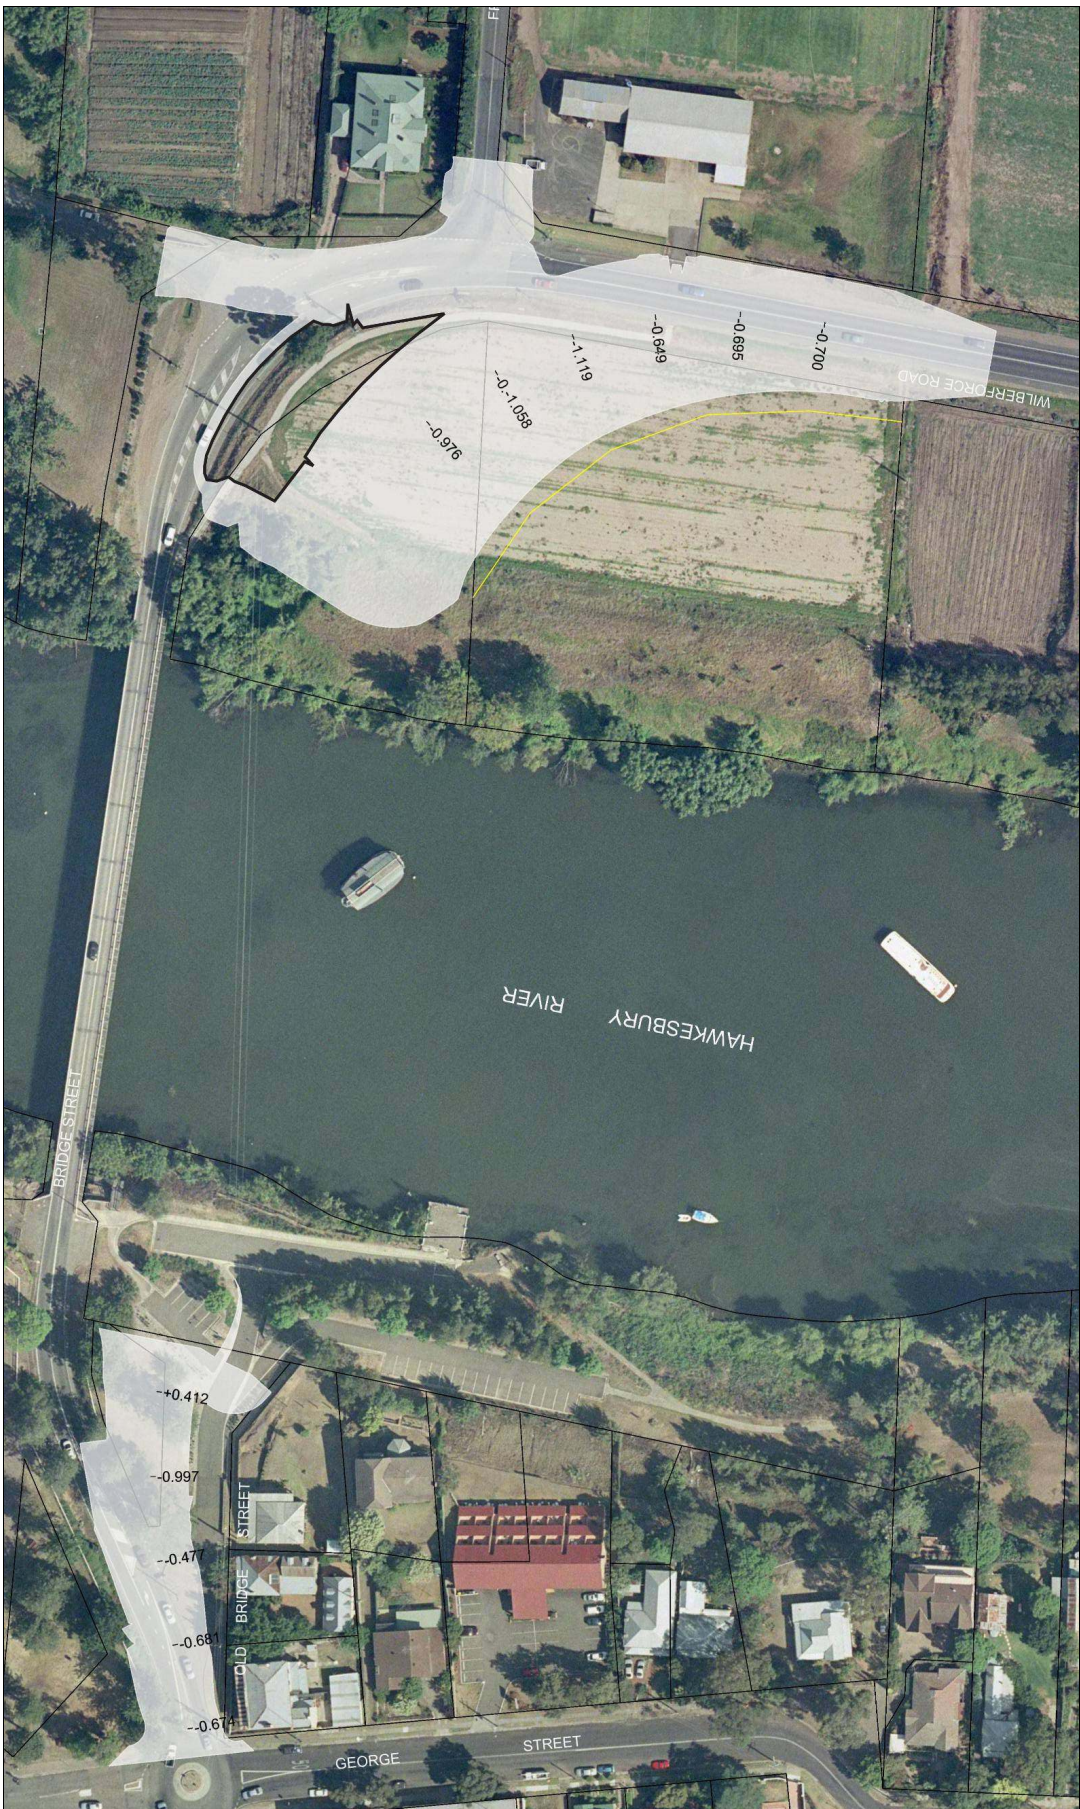
Figure 6.2 : Proposed earthwork levels of the replacement bridge (RTA 2008).

Removal of the existing Bridge is required as its retention alongside the replacement bridge could compromise the integrity of the new structure. The level of proposed earthworks on the Windsor side of the River is restricted to a maximum depth of 0.997m and the proposed alignment will include the consolidation of Thompson Square. Refer to Figures 6.1-6.4. The existing Bridge alignment involved the division of the Square with the introduction of the new Bridge Street. These proposed changes will move the alignment of the road and approach to the new bridge west of its current alignment. These works will also move the road away from heritage listed properties along Bridge Street. The works on the Wilberforce side of the River will involve earthworks to a maximum depth of 1.10m.

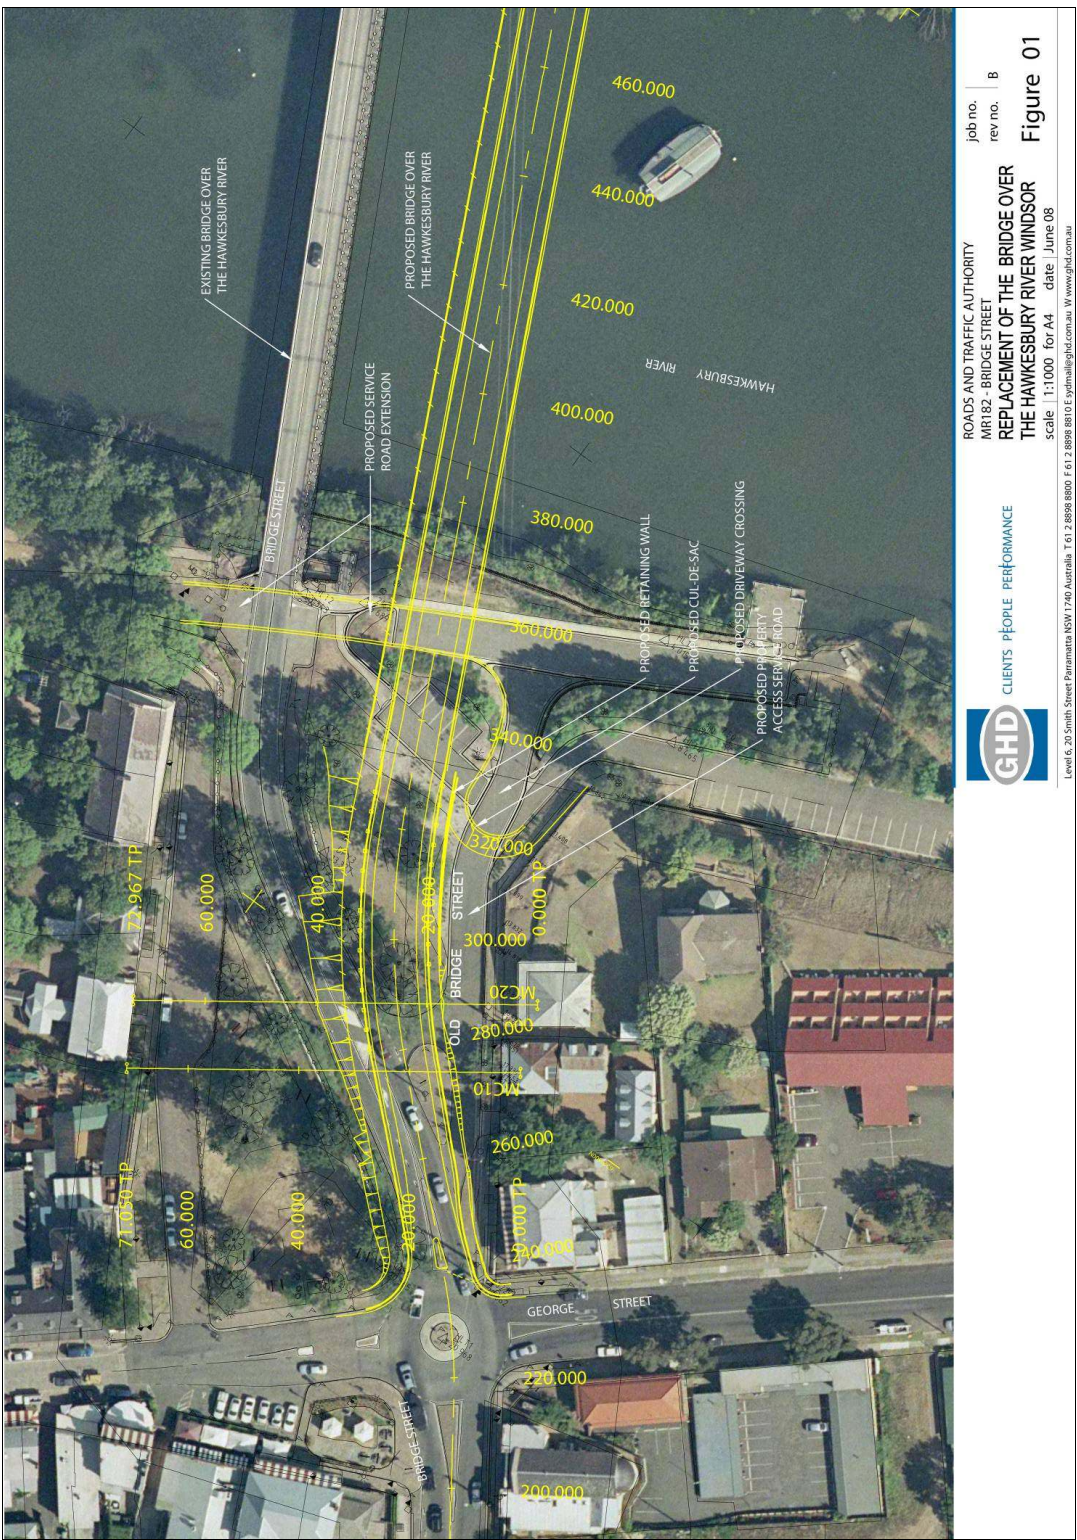
Figure 6.4: Plan indicating location of sections taken within Thompson Square (RTA 2008).
