Re: Formal complaint – Windsor Bridge Project – MBO and other matters.

As you know, the Windsor Bridge Replacement Project is a public infrastructure project that, over the past decade, has been the cause of escalating community concern.

**COMMUNITY ACTION FOR WINDSOR BRIDGE
FORMAL COMPLAINT
WINDSOR BRIDGE PROJECT:
ACID SULPHATE SOILS & MONOSULFIDIC BLACK OOZE
AND OTHER MATTERS**

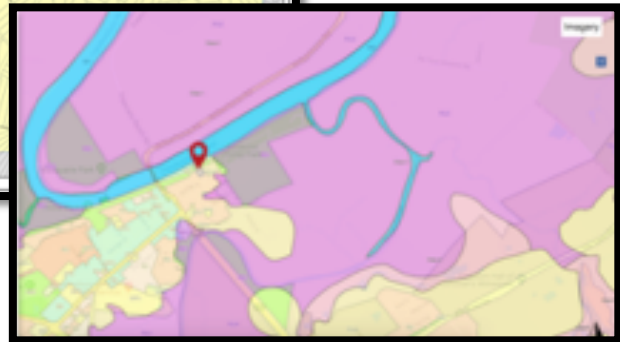
Below: a more detailed map of the area, sourced from NSW Government Planning Portal

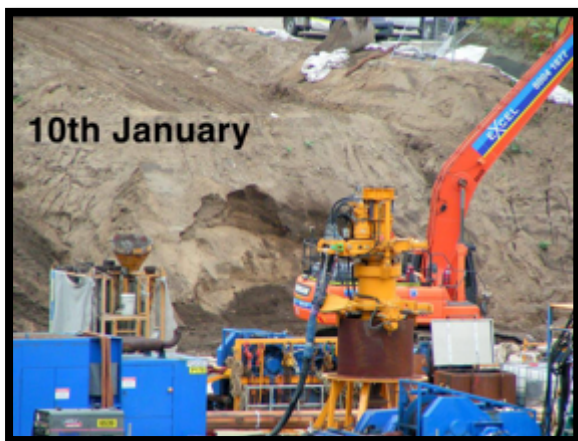
The image below, dated 10 January, clearly shows one example of the “slippage” the RMS says it has no issues with.

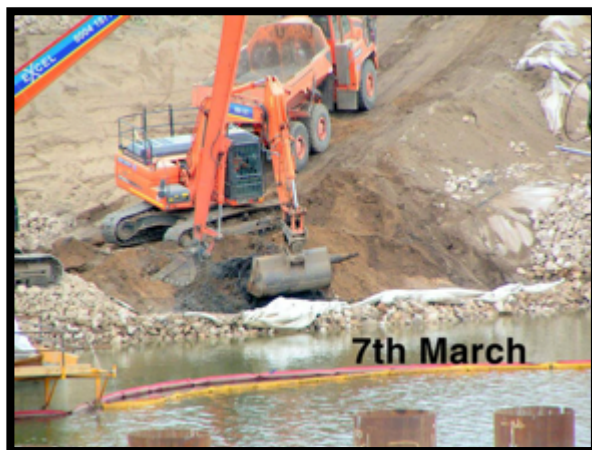
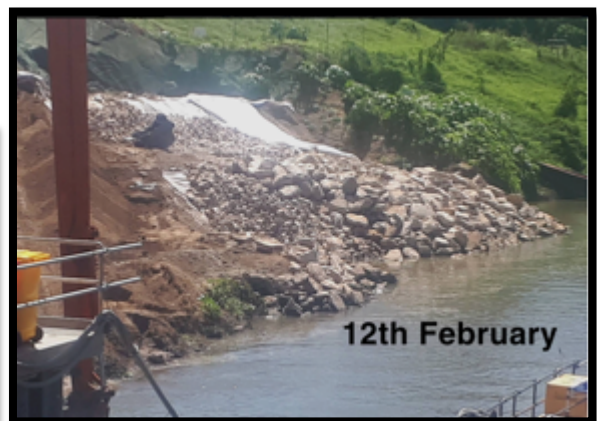
The text on the RMS website implies a continuous process of fill and compaction. Again as illustrated in these images, this is not the onsite reality, as the “stabilised” riverbank has actually been re-excavated...more than once.’

33. Why have sections of the bank been repeatedly re-excavated?

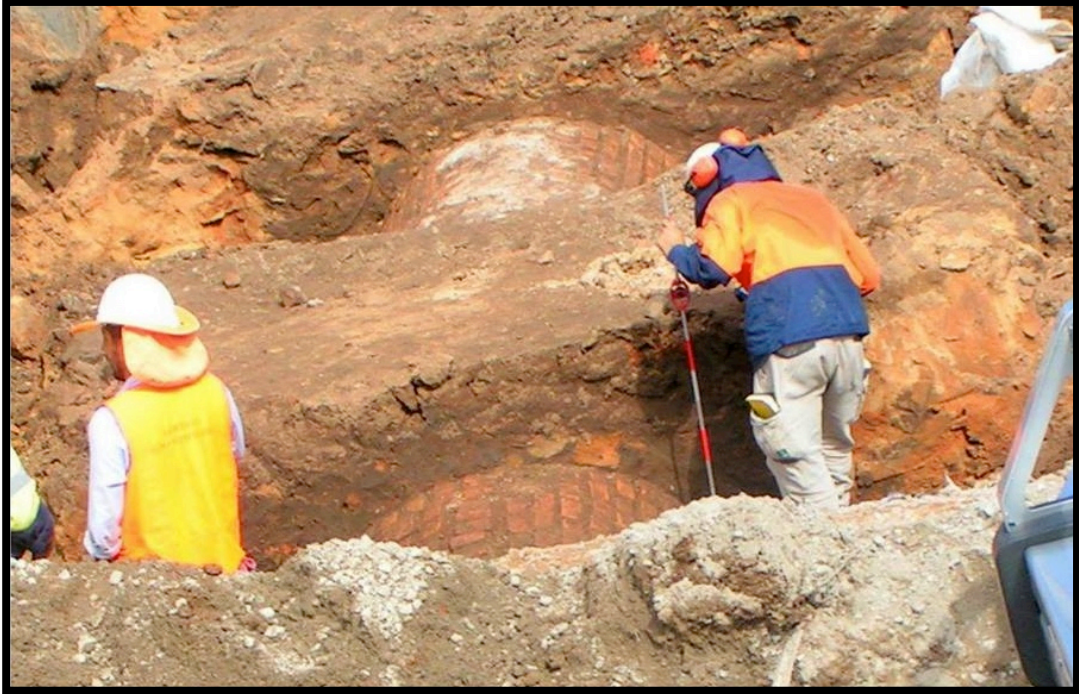
CAWB has just been made aware of this photograph, taken by a Community Observer (14/15.3.19)

The majority of the drain is now entombed, and yet, there is this unexpected photo, of a small section of the barrel drain, taken close to where the shared pedestrian pathway is.
