Windsor Bridge Replacement Project

Independent Heritage Review

August 2013

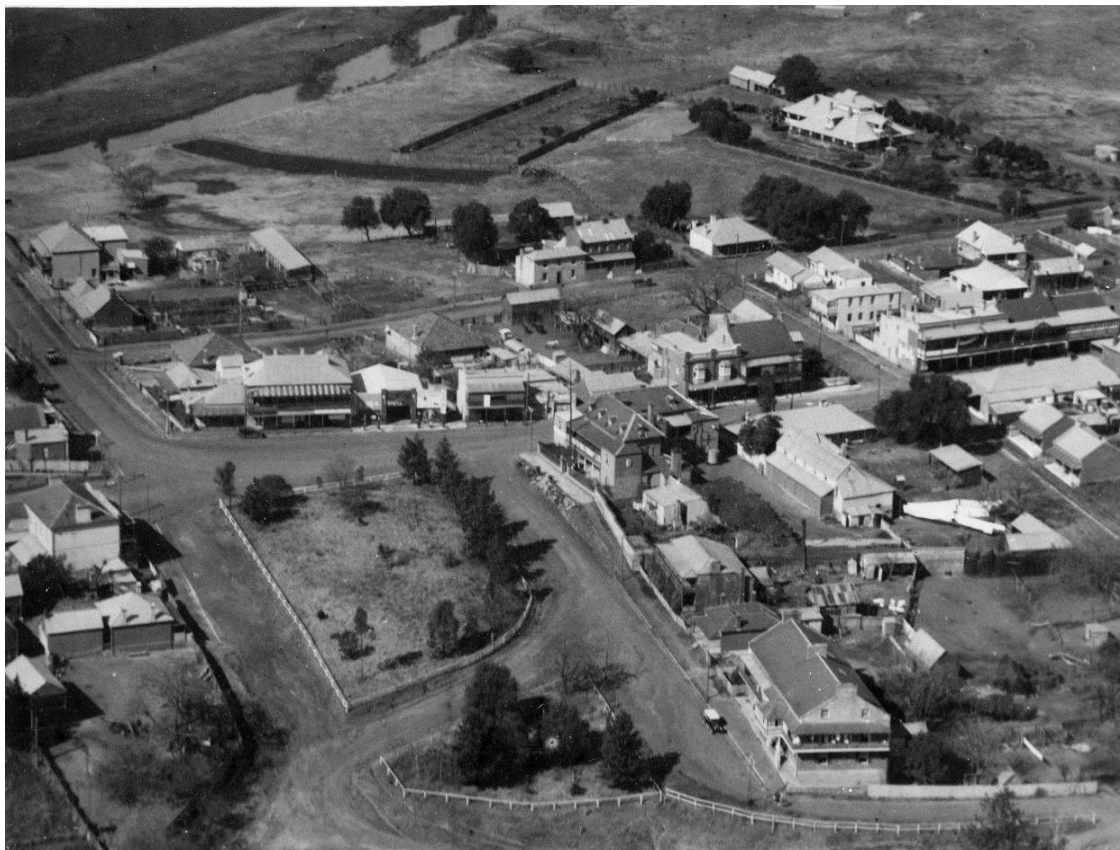
Figure 1: 1929 aerial photo showing the cart tracks coming down from the western road, in front of the Macquarie Arms Hotel, along the road cutting through the square and down to the bend at the bottom. There is little wear on the eastern 'Old Bridge Street'.

- Interpretation of the 1929 aerial photos is debatable. If you look at the wear patterns from where carts have used the road they are using the western road not Bridge Street. The cart tracks curving down to the river is very clear (Figure 1). There is little indication of cart tracks moving from the eastern road across the northern bend of cart tracks.
