**A Review and Consideration
of the
Structural Condition
of the existing
Windsor Bridge
Final Review**

Report on Structural Condition of the existing Windsor Bridge

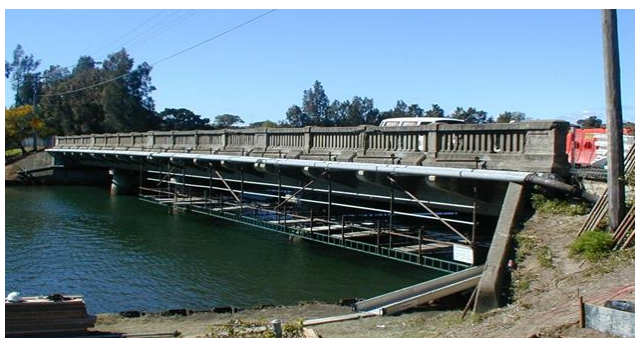
Before

RMS cited Wardell Road Bridge Rehabilitation Project [D5] as a local example of re-alkalisation of the bridge. On further enquiry with Marrickville Council this bridge, built in 1924, had 314m² re-alkalised 12 years ago and no additional maintenance has been required since that treatment. The structure was also treated with an anti-carbonating coating. This is not a standard coating as it takes into account the elevated alkalinity of the concrete after treatment.

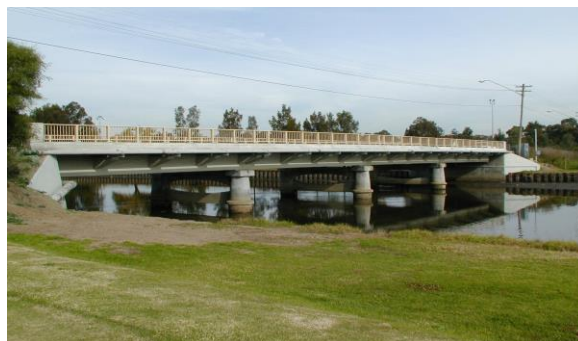
After

The process had no adverse impact on the appearance of the bridge (good for heritage) and only a few sporadic half road closures. Design was by GHD. [B11]

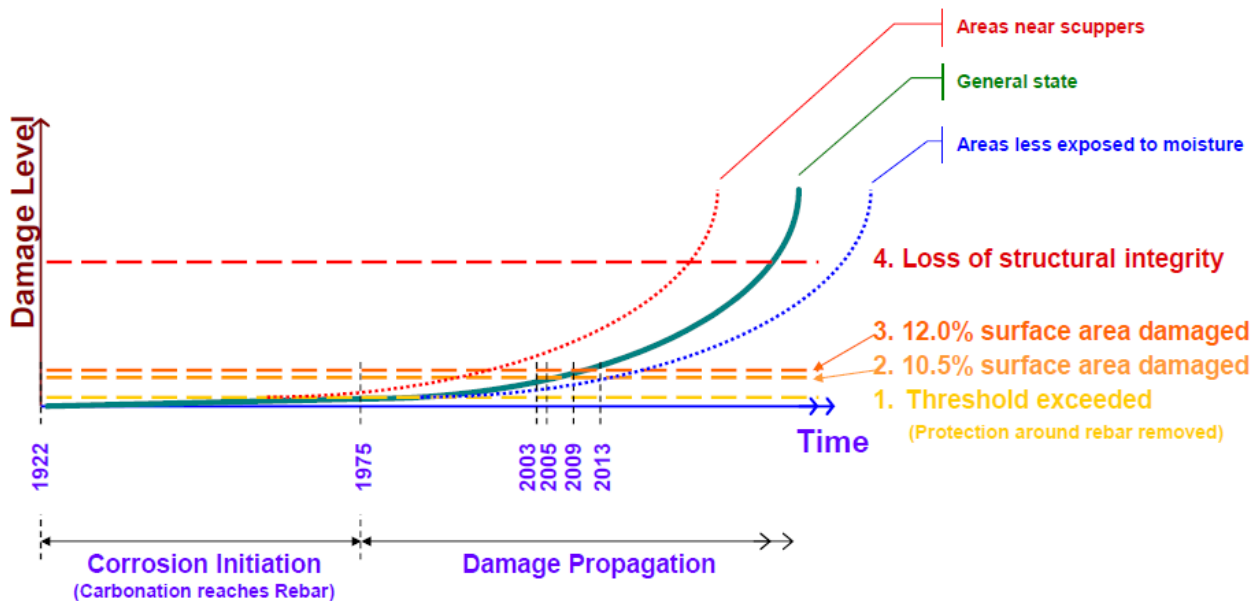
The date of corrosion initiation is not substantiated by RMS and the curves seem somewhat arbitrary without any backup calculations. For 2009, the chart seems to indicate a more extreme acceleration of deterioration (12%) than that observed in the inspection of 2009 (2.1%) (see Section 14 on Maintenance below).

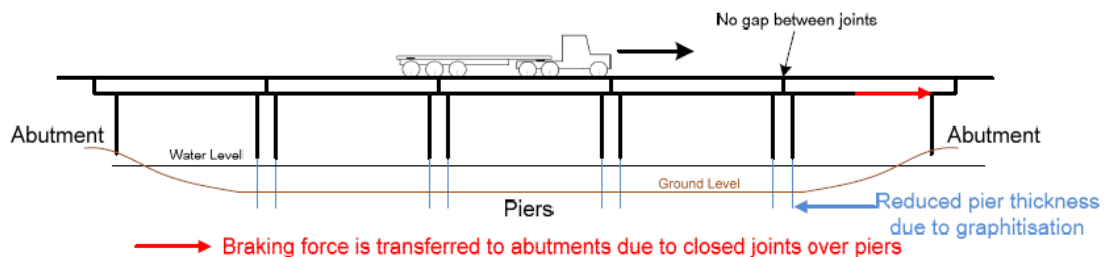
Currently as the joints are 'locked up' the forces from vehicle braking is transferred through the deck to the abutments and not transferred through the piers. (See reproduced RMS diagram below) [B5]

Currently locked up – low loads on piers

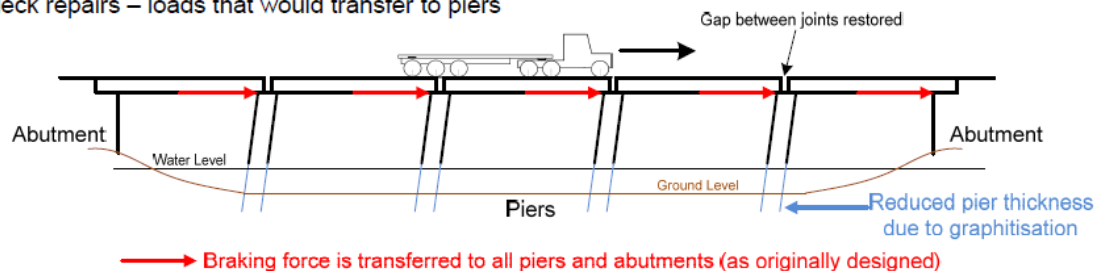
After deck repairs – loads that would transfer to piers

The braking load test undertaken on the bridge supports the theory that the bridge is locked up with negligible bending stresses recorded in the piers under the tests indicating that the horizontal forces are being shared by all the piers or being transferred to the abutments. This is fortuitous as the piers, which would otherwise transfer these braking loads, are in a condition whereby they may not be able to withstand the full braking forces (particularly Pier 5 which has significant circumferential cracking of its cast iron caisson).

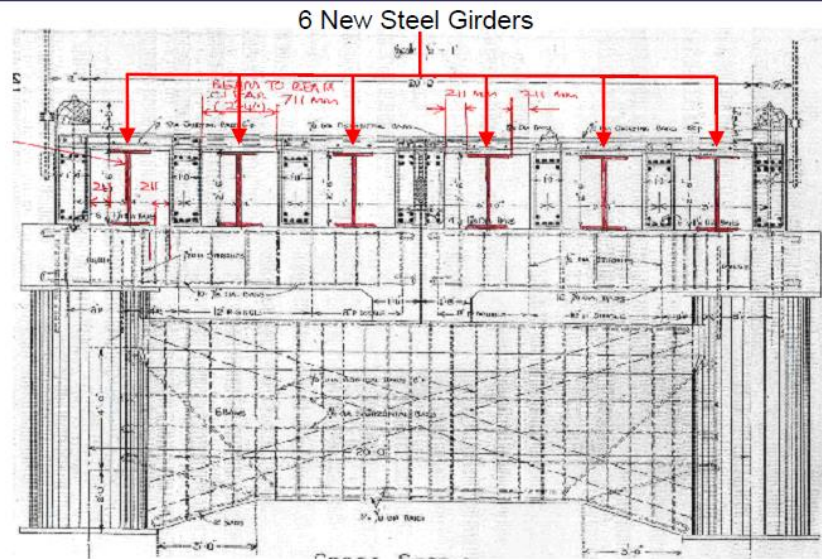
[Method Statement Pg. 3 Rehabilitation Report][B4V1.6]

- This method requires the closing of one lane for the duration of installation of steel beams as lifting and access points are required in the deck.
- This method requires considerable work at height which is a safety issue.

- Steel beams would be installed in sections requiring two splices per span which are made from below the existing deck. Splice design would need careful consideration as external top flange splice plates would be undesirable as they could become load concentration points. This is due to the tight tolerances associated with this method.

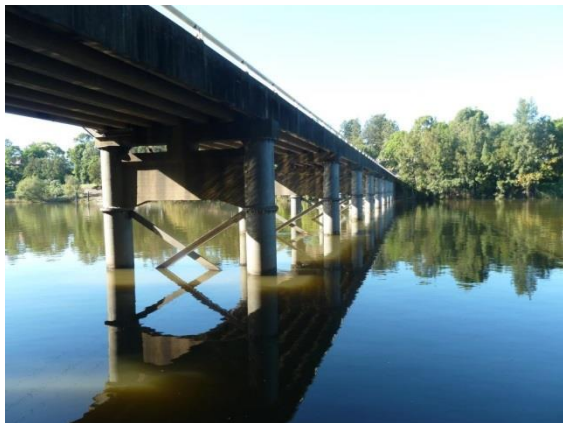
Span 10 and 9 beyond

Crack over pier headstock

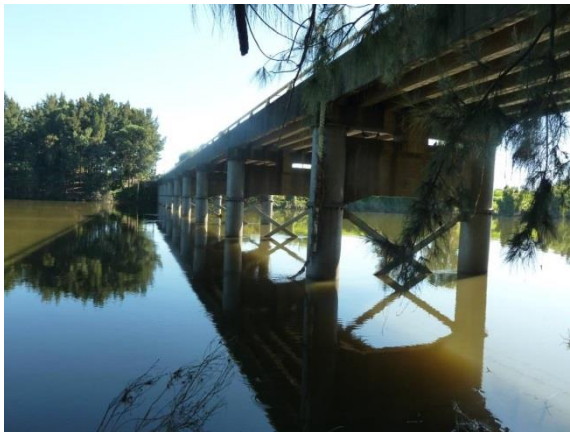
Span 1

Headstock reinforcement
showing perhaps as a result of
insufficient concrete cover
